BELZONA EXTENDS LIFE OF CONDENSER EXPANSION JOINT

ID: 719

Customer Location: *Power plant, Egypt.*

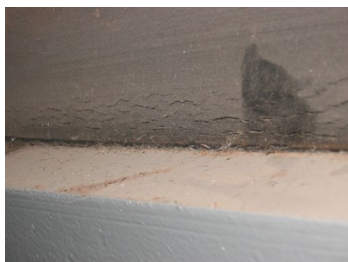
Both sides, top and bottom, of the rubber flexible joint had deteriorated.

- * The deteriorated rubber joint ,
- * Surface preparation of the joint ,
- * Conditioning the surface ,
- * Belzona® 2221 applied ,
