BELZONA EXTENDS LIFE OF CONDENSER EXPANSION JOINT

Customer Location: *Power plant, Egypt.*

The rubber expansion joint of the main condenser of the plant.

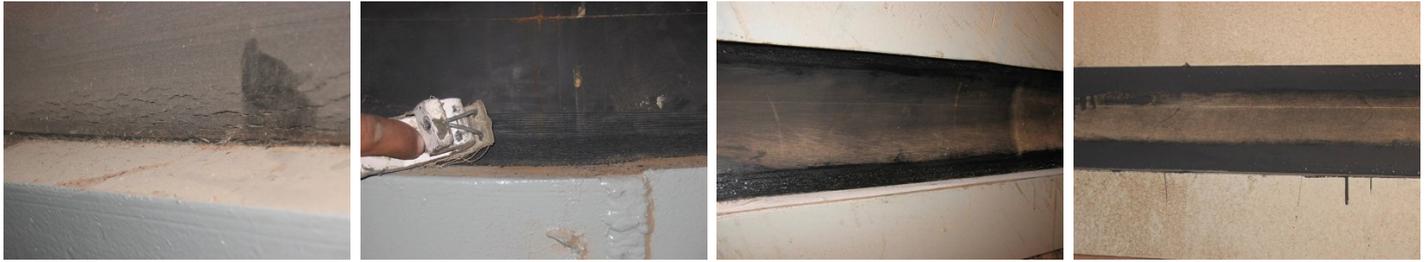
Photograph Descriptions

Both sides, top and bottom, of the rubber flexible joint had deteriorated.

- * The deteriorated rubber joint ,
- * Surface preparation of the joint ,
- * Conditioning the surface ,
- * Belzona® 2221 applied ,

Application was carried out in accordance with modified version of Belzona® Know-How System leaflet SHM-9.

Belzona® 2221 was able to quickly and successfully repair the rubber joint on the spot, extending its life without disrupting operation of the plant.
