BELZONA OVERCOMES ROOF DESIGN FLAW

ID: 723

Customer Location: River Dam Authority, Vinita, OK
Application Date: August, 2005

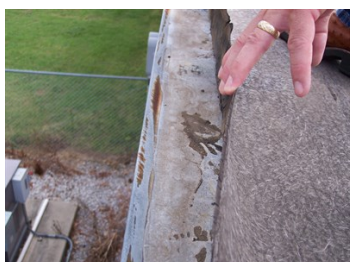
A small collection trough around the 660' perimeter of the roof had mistakenly been "engineered" into the original installation. Water collected and eventually drained under the roof sheets toward the center of the building until it found a leak path onto the ceiling.

- * The poor roof design allowing water to collect and enter ,
- * Conditioning of metal trim and roof sheet ,
- * Belzona® 3111 being applied through the Reinforcing Sheet ,
- * Completed application with entire building perimeter sealed with Belzona Membrane System ,

Application carried out according to Belzona Know-How System Leaflet RPA-1. After surface preparation a fully reinforced Belzona® 3111 system was applied so that it overlapped onto the metal perimeter trim and the main roof covering.
