BELZONA OVERCOMES ROOF DESIGN FLAW

Industry: Buildings & Structures
Application: RPA-Roof Problem Areas
Substrate: Darby gum roofing sheets and metal flashing.
Products: * Belzona® 3111 (Flexible Membrane) ,

Customer Location: River Dam Authority, Vinita, OK
Application Date: August, 2005

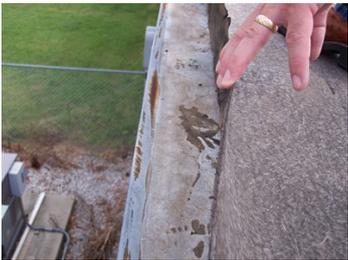
A small collection trough around the 660' perimeter of the roof had mistakenly been "engineered" into the original installation. Water collected and eventually drained under the roof sheets toward the center of the building until it found a leak path onto the ceiling.

- * The poor roof design allowing water to collect and enter ,
- * Conditioning of metal trim and roof sheet ,
- * Belzona® 3111 being applied through the Reinforcing Sheet ,
- * Completed application with entire building perimeter sealed with Belzona Membrane System ,

Application carried out according to Belzona Know-How System Leaflet RPA-1. After surface preparation a fully reinforced Belzona® 3111 system was applied so that it overlapped onto the metal perimeter trim and the main roof covering.
