CLASSIC PUMP REBURBISHMENT WITH BELZONA

ID: 738

Application: *CEP-Centrifugal Pumps*

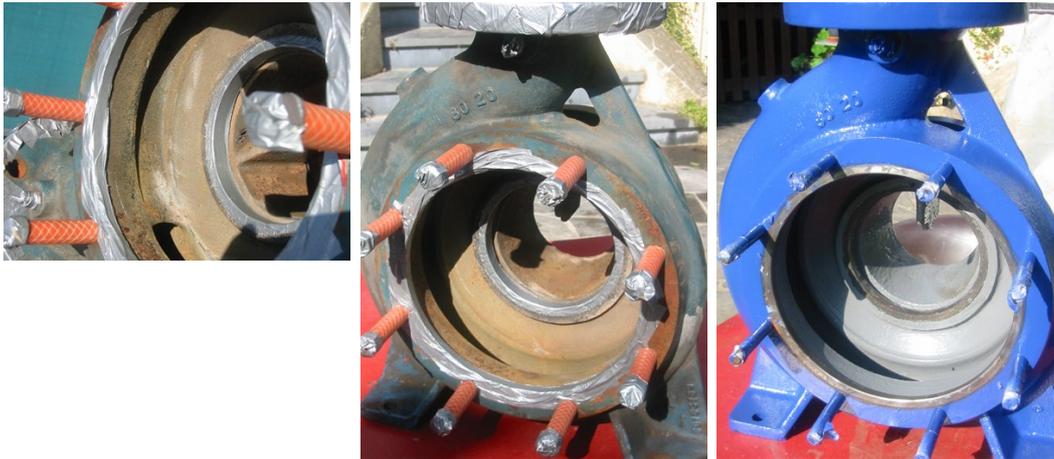
Photograph Descriptions

Erosion/corrosion from constant water flow within the pump caused erosion in critical parts of the housing.

- * Rebuilding profiles underway ,
- * Another view of profiles ,
- * Completed application ,

The application was carried out in accordance with Belzona Know-How System Leaflet CEP-2 & CEP-5.
