# CLASSIC PUMP REFURBISHMENT WITH BELZONA

ID: 738

Application: CEP-Centrifugal Pumps

Customer Location: Copper Manufacturer, Belgium

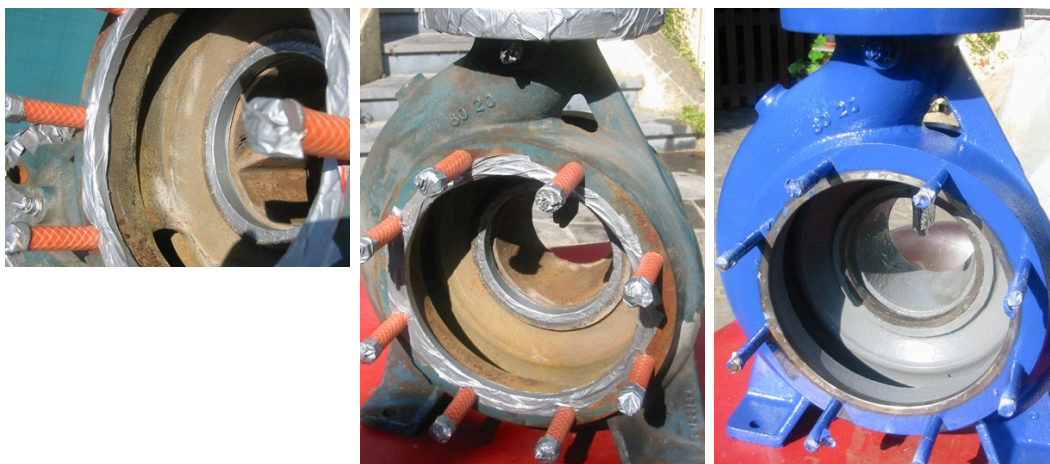
Erosion/corrosion from constant water flow within the pump caused erosion in critical parts of the housing.

- \* Rebuilding profiles underway ,
- \* Another view of profiles ,
- \* Completed application ,

The application was carried out in accordance with Belzona Know-How System Leaflet CEP-2 & CEP-5.
