BELZONA MANWAY OPENING

ID: 74

Industry: Chemical & Petrochemical
Application: TCC-Tanks and Chemical Containment Areas
Substrate: Stainless Steel
Products: * Belzona® 1111 (Super Metal) ,

Customer Location: Petroleum Refinery in Texas
Application Date: 1991

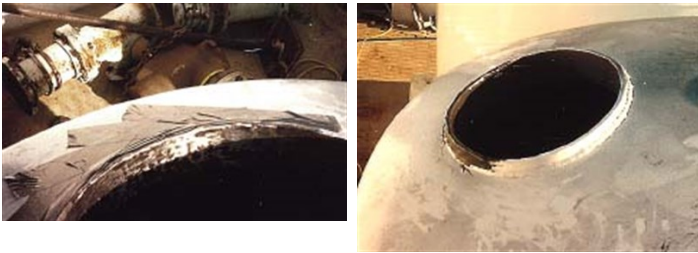
Photograph Descriptions

Opening on chemical tank was corroded to the point where a good seal was not possible.

- * Surface preparation performed with the repair area taped off. ,
- * Manway rebuilt. ,

Manway opening on chemical storage tank.

The application was carried out in accordance with a modified version of Belzona Know-How Leaflet TCC-10.

For only \$128 in Belzona® 1111 (Super Metal), downtime and expensive welding was averted. The repair has held for many years, and is still in perfect condition.
