# BELZONA REPAIR OF RUBBER IMPELLER

ID: 744

Industry: Water / Wastewater  
Application: SHM-Solids Handling Machinery

Customer Location: Chemical Plant, Italy  
Application Date: November 2005

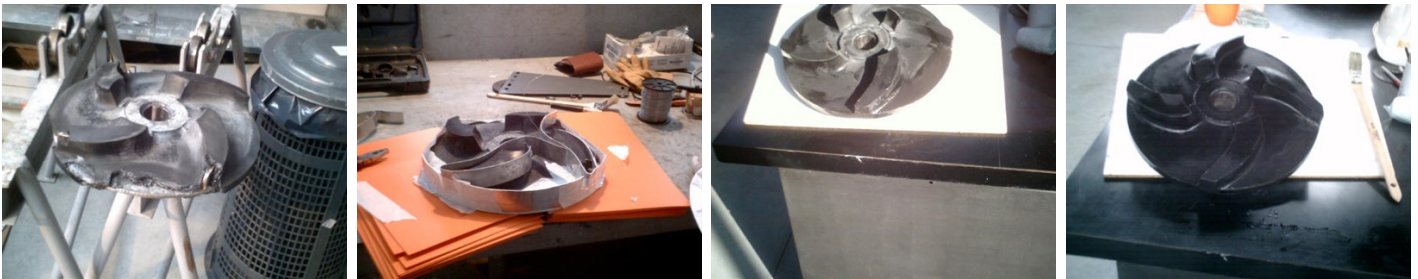
Whilst casing had little damage, the impeller vanes were very badly damaged and needed rebuilding.

- \* The damaged impeller ,
- \* Aluminum formers in place ,
- \* Casting underway ,
- \* The finished impeller ,

Application was carried out in accordance with Belzona Know-How System Leaflet SHM-9. Aluminum forms were prepared and Belzona® 2131 poured in to restore profiles. Belzona® 2311 used to reform smaller areas.
