Belzona Repairs Rudder Housing

ID: 7461

Industry: *Marine*
Application: *SOS-Ships and Offshore Structures*

Customer Location: *Drydock, Greenock, Scotland*
Application Date: *March 2017*

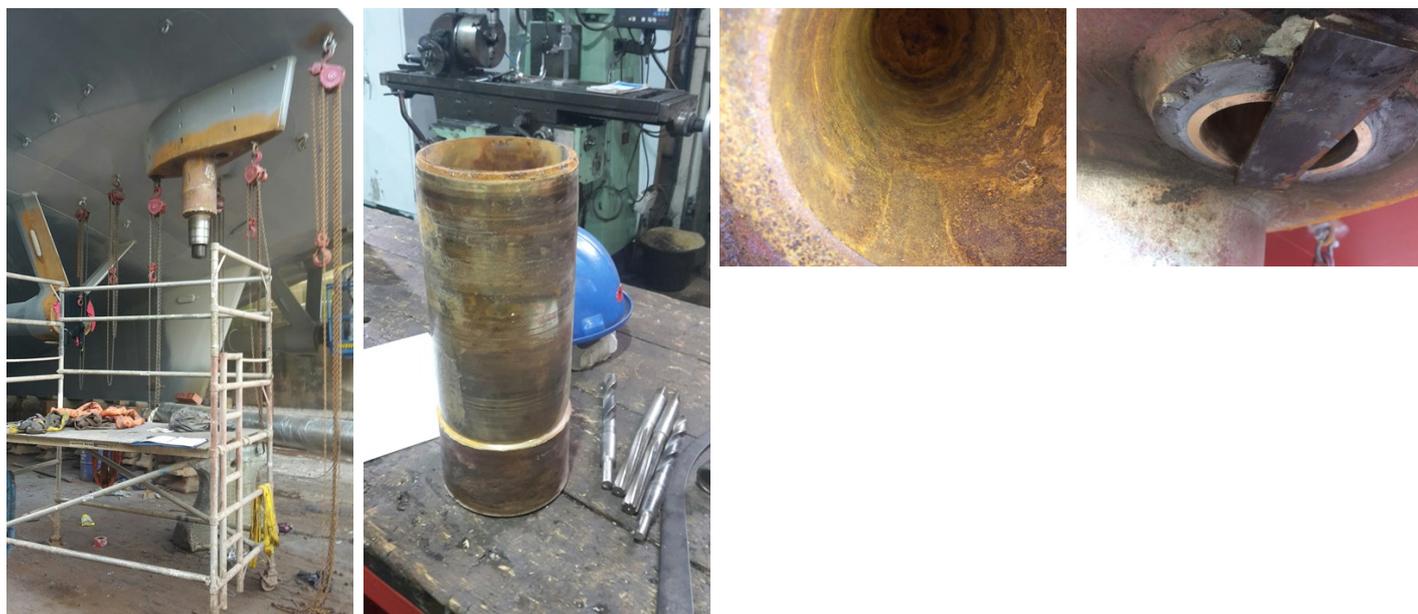
The normal repair method would involve shrink fitting the bush back into place. The erosion/corrosion on the housing & bush was too severe for this method to be used.

- * 1- Area to be repaired ,
- * 2- Bush showing large amounts of wear ,
- * 3- Housing before grit blasting ,
- * 4- Bush bonded in & aligned ,

Passenger ferry in dry dock. A becker rudder pintle bush had become loose due to galvanic corrosion. The bush had slipped down the rudder pin & had begun to wear on the housing itself.

The application was carried out in accordance with Belzona System Leaflet SOS-9. The bush was machined to give a 5mm clearance.

The housing was grit blasted and Belzona 1111 applied to the two parts, then the bush was pressed into position. Care had to be taken to ensure the correct alignment of the piece.
