Belzona Repairs Rudder Housing

Industry: Marine
Application: SOS-Ships and Offshore Structures

Customer Location: Drydock, Greenock, Scotland
Application Date: March 2017

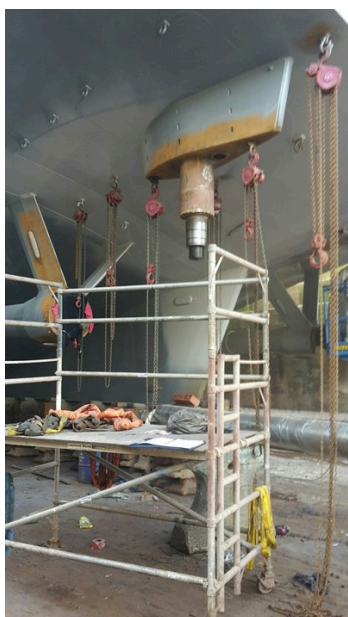
- * 1- Area to be repaired ,
- * 2- Bush showing large amounts of wear ,
- * 3- Housing before grit blasting ,
- * 4- Bush bonded in & aligned ,

Passenger ferry in dry dock. A becker rudder pintle bush had become loose due to galvanic corrosion. The bush had slipped down the rudder pin & had begun to wear on the housing itself.

The application was carried out in accordance with Belzona System Leaflet SOS-9. The bush was machined to give a 5mm clearance.

The housing was grit blasted and Belzona 1111 applied to the two parts, then the bush was pressed into position. Care had to be taken to ensure the correct alignment of the piece.

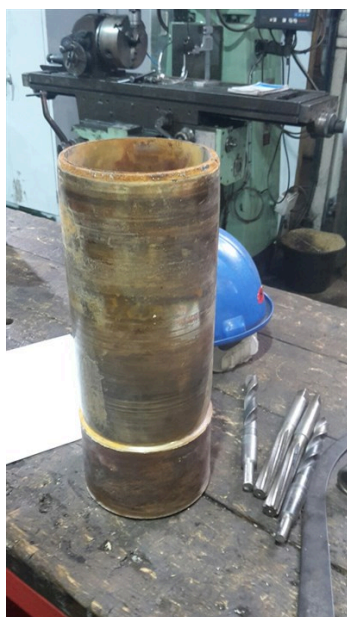
The normal repair method would involve shrink fitting the bush back into place. The erosion/corrosion on the housing & bush was too severe for this method to be used.
