# MARINE CHILLER UNITS MADE SHIP SHAPE WITH BELZONA

Industry: *Marine*  
Application: *HEX-Heat Exchangers*  
Substrate: *Aluminium*  
Products: *\* Belzona® 1111 (Super Metal) ,*  
*\* Belzona® 1212 ,*  
*\* Belzona® 1321 (Ceramic S-Metal) ,*

Customer Location: *Deep Sea Diving Vessel, Teesside, UK*  
Application Date: *March 2017*

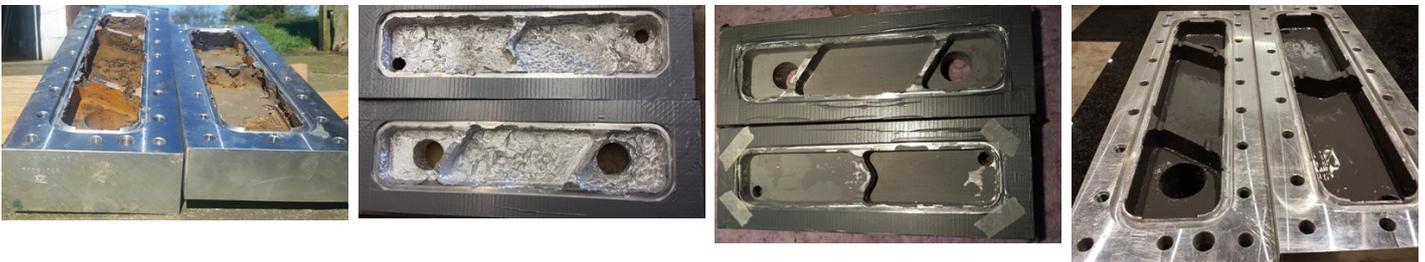
## Photograph Descriptions

*These aluminium chiller units had suffered severe pitting and metal loss caused by microbial attack and bi-metallic corrosion. The newly commissioned ship had a series of 17 chiller units and two of these had been severely damaged in just 8 months of service.*

- \* 1. Badly corroded chiller block ,
- \* 2. Corrosion cleaned and roughened back to bright metal ,
- \* 3. Damage rebuilt with Belzona 1111 & 1212 ,
- \* 4. Coated with Belzona 1321 ,

Work was carried out in accordance with Belzona system leaflets HEX-2 & HEX-3. In addition to the extensive rebuilding needed, there was also a 2mm wide gasket lip to rebuild. Due to the small scale of the work, a router and pendant drill were used to dress back the Belzona metal repairs before lining with Belzona 1321.

The Belzona 1111 allowed for a very precise and accurate rebuild of the unit back to its original dimensions. Only one unit at a time could be taken off the ship, so to help with time limitations, Belzona 1212 was also used in the rebuild work. Finally the Belzona 1321 was used to create an erosion resistant lining to prevent further damage. The vessels chief engineer was impressed with the
