BELZONA SUPERWRAP II PROTECTS UNDERGROUND PIPELINE

Customer Location: Refinery, Shaanxi, China
Application Date: July 2016

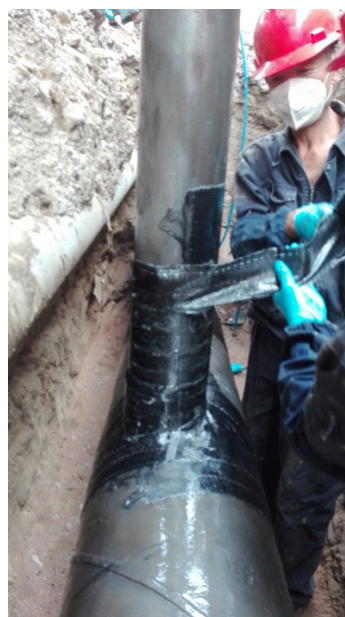
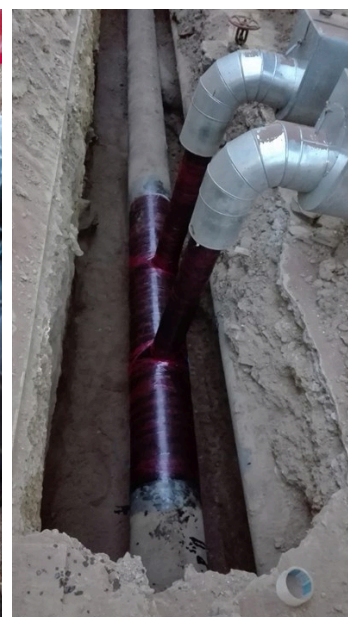
Photograph Descriptions

The pipe external wall had corroded due to the long-term humid environment. Pitting corrosion had led to significant wall thinning.

- * 1. Severe corrosion in the thinned-wall ,
- * 2. Surface preparation underway ,
- * 3. Application of Belzona SuperWrapII ,
- * 4. Application completed ,

The application was carried out by a validated installer following the specific design generated for this application.

This Belzona SuperWrap II application presented an effective and low-cost repair solution. Rather than expensive and time-consuming replacement of the whole pipeline, the Belzona SuperWrap II application required no hot work and was completed rapidly and with reliable results.
