# PUMP SUMP PROTECTION WITH BELZONA ON OIL TANKER

Industry: Marine  
Application: TCC-Tanks and Chemical Containment Areas  
Substrate: Steel  
Products: Belzona® 1391 (Ceramic HT Metal)

Customer Location: Oil Tanker owner, Palermo, Italy  
Application Date: February 2006

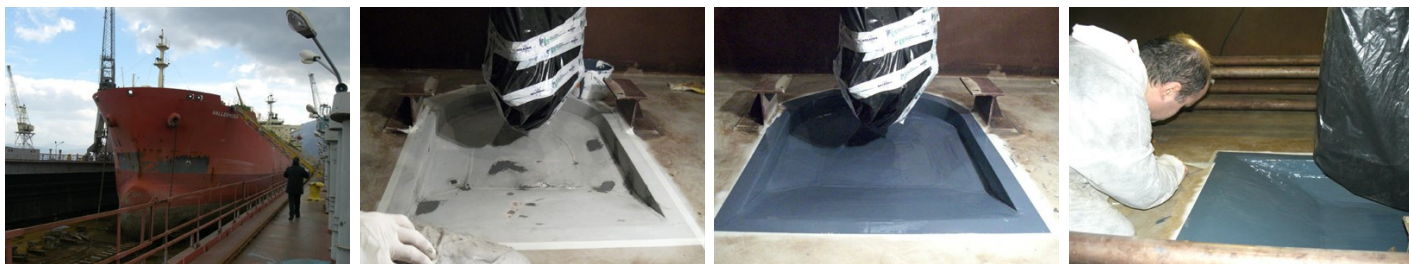
## Photograph Descriptions

Erosion/Corrosion due to the constant liquid flow over the sump during cargo transfer.

\* The tanker in dock. , \* Sump after blasting. , \* Sump coated with Belzona® 1391. , \* Completing the application. ,

Application was carried out in accordance with Belzona Know-How System Leaflet TCC-5.
