IMPELLER RESTORATION WITH BELZONA KEEPS BIOMASS PRODUCTION ONLINE

Industry: Power
 Application: CEP-Centrifugal Pumps
 Substrate: Steel
 Products: * Belzona 1311 (Ceramic R-Metal) ,
 * Belzona 1321 (Ceramic S-Metal) ,

Customer Location: Bio-engineering Company, Portugal
 Application Date: 2014

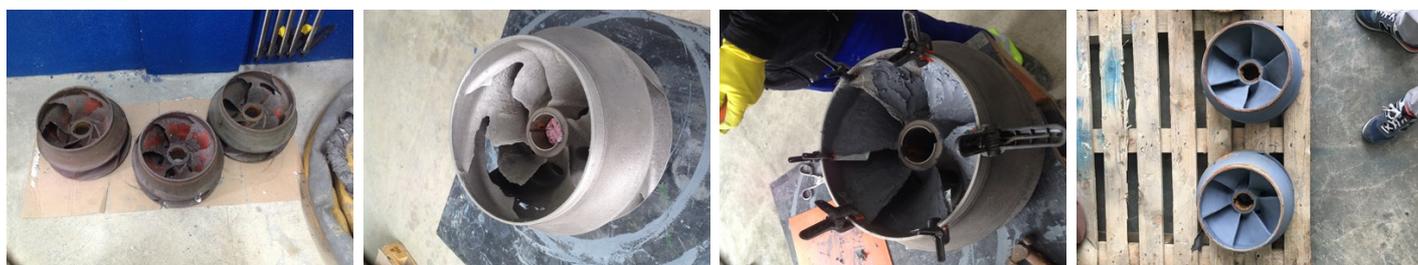
Photograph Descriptions

As part of their operations, they needed to restore three damaged pump impellers. In order to eliminate the growth of any microbiological matter which could affect the algae's development or quality, the producer uses strong chemicals to clean the process equipment. Each pump is cleaned every one to two weeks. The frequency of this cleaning had resulted in the pump impellers becoming damaged after just one year in service.

- * 1. Three impellers damaged in 2014 ,
- * 2. Grit blasted impeller highlights the extensive damage ,
- * 3. Shape restored using wire mesh and Belzona 1311 ,
- * 4. Impellers still in perfect condition in 2017 ,

Application completed in accordance with Belzona System Leaflet CEP-1 and CEP-3. The eroded impeller design was rebuilt using a combination of wire steel mesh and Belzona 1311. Once the shape was restored, the impellers were coated using Belzona 1321 to protect form further damage.

In 2017, the pump impellers were revisited and found to still be in perfect condition after two and a half years of service. Compared to the short lifespan and excessive damage when unprotected, the Belzona coating improved the longevity of the component significantly. Due to the overwhelming success of these applications, Belzona has been chosen to coat four new impellers in 2017.
