IMPELLER RESTORATION WITH BELZONA KEEPS BIOMASS PRODUCTION ONLINE

Application: CEP-Centrifugal Pumps

Customer Location: Bio-engineering Company, Portugal

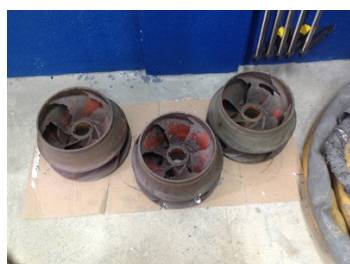
As part of their operations, they needed to restore three damaged pump impellers. In order to eliminate the growth of any microbiological matter which could affect the algae's development or quality, the producer uses strong chemicals to clean the process equipment. Each pump is cleaned every one to two weeks. The frequency of this cleaning had resulted in the pump impellers becoming damaged after just one year in service.

- * 1. Three impellers damaged in 2014 ,
- * 2. Grit blasted impeller highlights the extensive damage ,
- * 3. Shape restored using wire mesh and Belzona 1311 ,
- * 4. Impellers still in perfect condition in 2017 ,

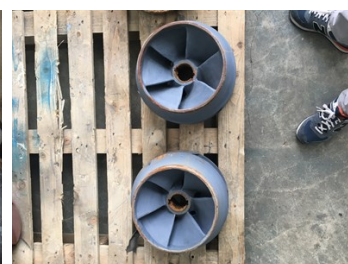
In 2017, the pump impellers were revisited and found to still be in perfect condition after two and a half years of service. Compared to the short lifespan and excessive damage when unprotected, the Belzona coating improved the longevity of the component significantly. Due to the overwhelming success of these applications, Belzona has been chosen to coat four new impellers in 2017.
