Belzona Protects Screw Conveyor against Abrasion

Customer Location: Biomass power plant, France

Application: SHM-Solids Handling Machinery

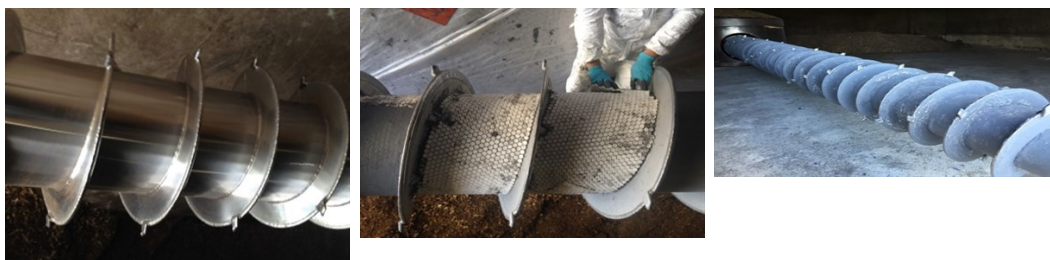
Photograph Descriptions

Abrasion of welds. Welding of the screw every 12 months. Service life: 5 years

- * 1. Grit-blasted screw conveyor ,
- * 2. Application of ceramic tiles on Belzona 1311 ,
- * 3. Finished application ,

11 meter long stainless steel screw conveyor, tube Ø 700 for the transport of wood bark.

The surface was grit-blasted and a layer of Belzona 1311 was applied. Ceramic tiles were placed and coated with Belzona 1311. The surface was then grit-blasted and Belzona 1341 was applied in 2 layers.

Visit after 12 months: no visible abrasions or tile detachment
