BELZONA PROTECTS RAIL CARRIAGE ROOFS

Customer Location: *Railway Operator, Portugal*

Application: *RPA-Roof Problem Areas*

Roof on railway carriage

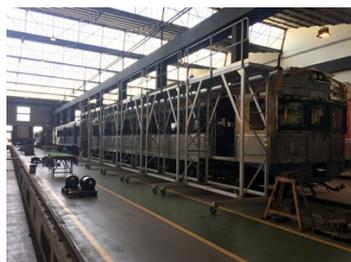
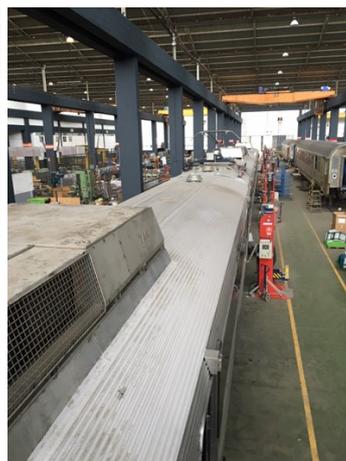
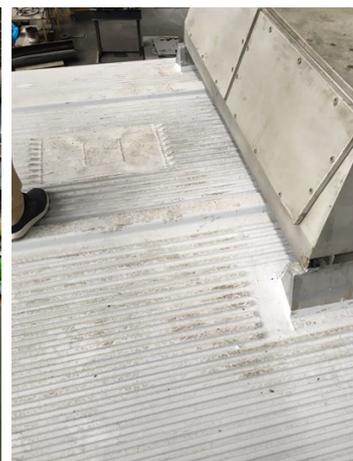
Water leaks on the roofs due to presence of small cracks and holes made to install specific furniture.

After conditioning the substrate with Belzona 3921 (GSC Conditioner), a fully reinforced Belzona 3111 system (including Belzona 9311 reinforcement sheet) was applied to the entirety of the carriage roof. The application was carried out in accordance with Belzona Know-How System Leaflets RPA-01 & RPA-08.
