BELZONA PROTECTS RAIL CARRIAGE ROOFS

ID: 7487

Application: *RPA-Roof Problem Areas*

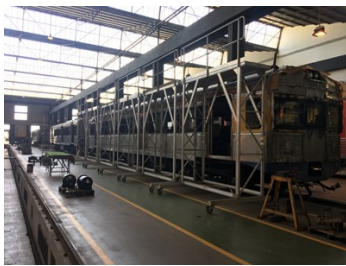
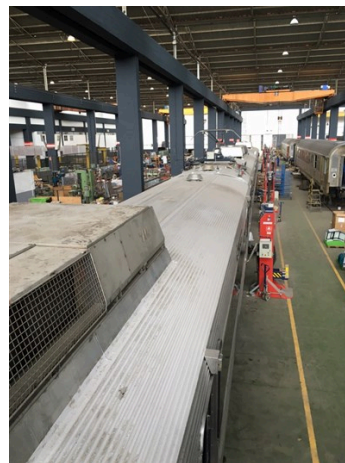
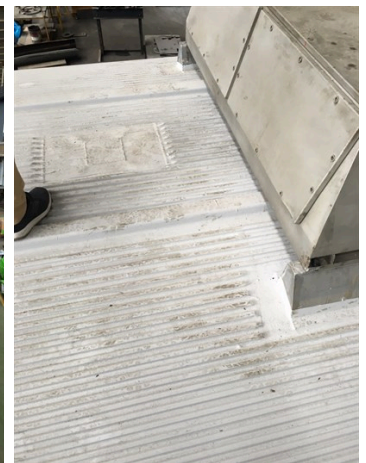
Water leaks on the roofs due to presence of small cracks and holes made to install specific furniture.

Roof on railway carriage

After conditioning the substrate with Belzona 3921 (GSC Conditioner), a fully reinforced Belzona 3111 system (including Belzona 9311 reinforcement sheet) was applied to the entirety of the carriage roof. The application was carried out in accordance with Belzona Know-How System Leaflets RPA-01 & RPA-08.
