# BELZONA STOPS LEAKS AT A PUBLIC HOUSING AUTHORITY

ID: 7488

**Customer Location:** Housing Authority, New York, USA  
**Application Date:** March 2016

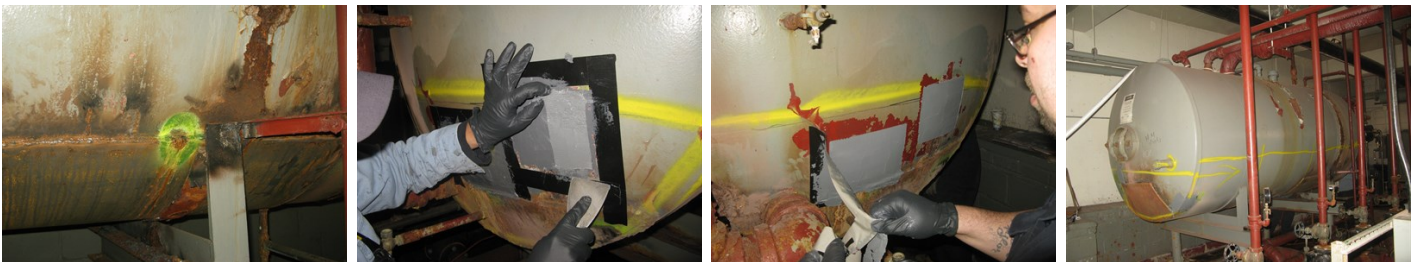
The condensate tank had moderate to severe corrosion in various spots with 11 existing leaks. This led to the room being regularly flooded.

- \* 1 - The leaking tank ,
- \* 2 - Application of Belzona materials ,
- \* 3 - Removing the masking tape ,
- \* 4 - The tank following after the completed application. ,

Application was carried out according to a modified version of Belzona system leaflet TCC-1. On the day of repair, the tank was drained prior to Belzonas arrival. Belzona 9341 reinforcement tape was used in conjunction with Belzona 1212 and Belzona 1111 to add mechanical strength and bridge gaps over larger holes. The tank was back in service by the end of the day.
