BELZONA PROVIDES EROSION CORROSION PROTECTION TO ORE THICKENER

ID: 7491

Customer Location: *Gold Mine, Mauritania*
 Application Date: *September 2015*

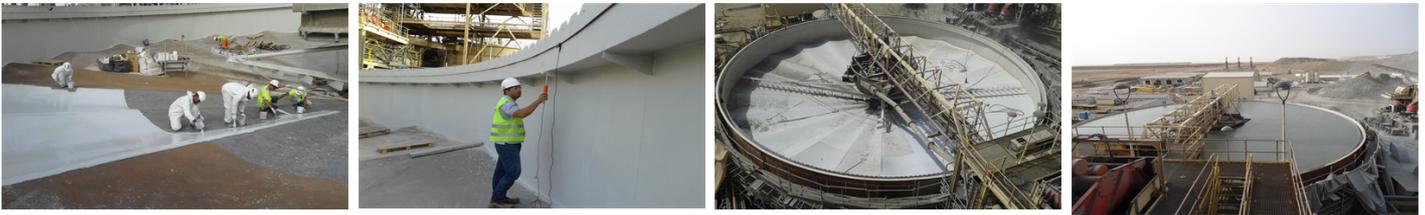
Photograph Descriptions

Both the wall and bottom areas of the thickener were suffering from general corrosion damage. Also, there was a significant presence of erosion on the bottom area up to the height of the rotary arm caused by the slurry.

- * 1. Application in process ,
- * 2. Inspection of Belzona 1331 ,
- * 3. Thickener fully protected with Belzona 1331 ,
- * 4. Thickener in service after completion of the application. ,

The coating was applied to the entire thickener according to the Belzona Know-How System Leaflet TCC-5.

Customer was looking for a long term corrosion protection and erosion resistant coating. Feedback from customer in November 2016 confirmed that thickener was still working well with no issues.
