# BELZONA RESTORES AND PROTECTS PUMP FROM FOOD INDUSTRY

**Industry:** Food & Drink  
**Application:** CEP-Centrifugal Pumps  
**Substrate:** Steel  
**Products:** \* Belzona 1111 (Super Metal) ,  
\* Belzona 1321 (Ceramic S-Metal) ,

**Customer Location:** Food Company, South Africa  
**Application Date:** March 2017

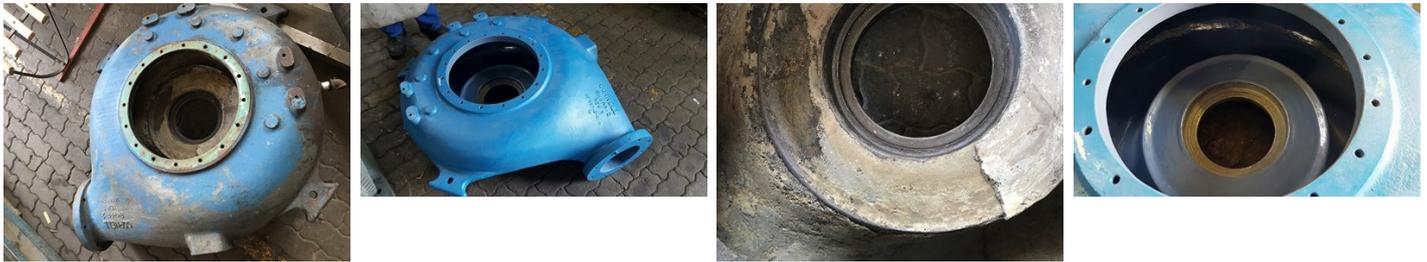
The existing coating was delaminating from the substrate and parts of this coating were going through the process which was unacceptable as it is a food application.

- \* 1 - Pump Casing before cleaning & blasting ,
- \* 2 - Pump Casing after coating work completed ,
- \* 3 - Pump Casing internals before repair ,
- \* 4 - Pump Casing internals after coating had been completed. ,

The application was carried out in accordance with Belzona System Leaflet CEP-3 and CEP-05. The old coating had to be removed. Once this was completed the substrate was suitably prepared by grit blasting. Belzona 1111 was applied to rebuild worn areas and Belzona 1321 was applied over the entire casing and backplate.
