BELZONA KEEPS THE TANK AFLOAT!

Industry: Oil & Gas
Application: TCC-Tanks and Chemical Containment Areas
Substrate: Carbon Steel
Products: * Belzona 1391T,

Customer Location: Offshore oil production platform, Gabon
Application Date: March 2017

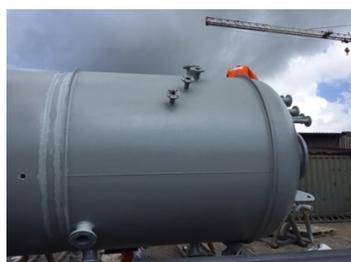
The original coating had failed in most areas. Pitting on the bottom head and on the shell manway was of particular concern.

- * 1. View of the tank ,
- * 2. First coat application completed on the shell ,
- * 3. Second coat application in progress ,
- * 4- Second coat application completed on the inner part of the tank ,
