# BELZONA KEEPS THE TANK AFLOAT!

Industry: Oil & Gas  
Application: TCC-Tanks and Chemical Containment Areas  
Substrate: Carbon Steel  
Products: \* Belzona 1391T,

Customer Location: Offshore oil production platform, Gabon  
Application Date: March 2017

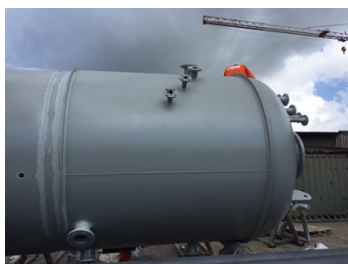
The original coating had failed in most areas. Pitting on the bottom head and on the shell manway was of particular concern.

- \* 1. View of the tank ,
- \* 2. First coat application completed on the shell ,
- \* 3. Second coat application in progress ,
- \* 4- Second coat application completed on the inner part of the tank ,

Application was carried out in accordance with Belzona Know-How System Leaflet TCC-5.
