# Belzona SuperWrap Repairs vessel nozzles online

ID: 7495

Customer Location: CNOOC Shanghai

Application Date: June, 2017

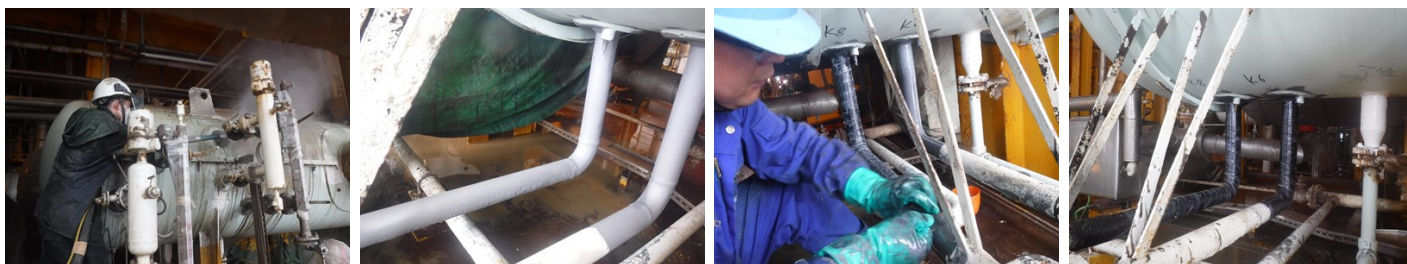
## Photograph Descriptions

Offshore platform vessel nozzles were corroded by CUI, and some small bore nozzles were leaking.

\* 1. Vapor blasting 2. Nozzle after vapor blasting 3. SWII application 4. SWII applicataion finished ,

SWII was designed and applied according to ISO 24817 standard. The explosion-proof vapor blasting was taken for surface preparation. VPF-11 was followed.

Traditional welding must shut down the whole platform, clean the vessel, this will take at least one week, Belzona SW can repair the corroded nozzle online and prevent huge shut down loss. Total 6 vessels and 92 nozzle was repaired.
