# Saving the belt with Belzona!

Application: SHM-Solids Handling Machinery

2 - 50" Conveyor belts lifting grain from rail cars to silos.

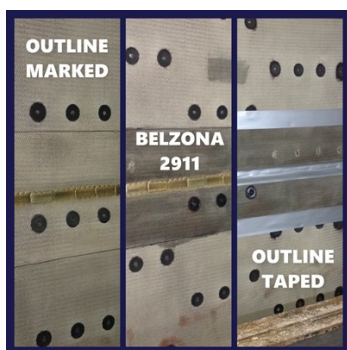
\* 1. The silos. 2. Belt prep and Belzona 2911 QD Conditioner. 3. First layer of Belzona 2111 D&A Hi-Build Elastomer. 4. Application complete. ,
