# Saving the belt with Belzona!

Application: SHM-Solids Handling Machinery

2 - 50" Conveyor belts lifting grain from rail cars to silos.

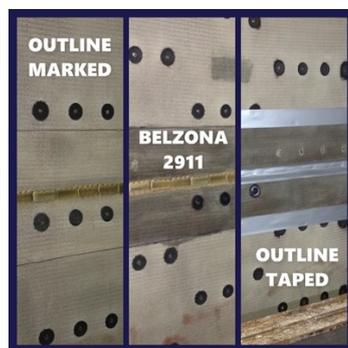
\* 1. The silos. 2. Belt prep and Belzona 2911 QD Conditioner. 3. First layer of Belzona 2111 D&A Hi-Build Elastomer. 4. Application complete. ,

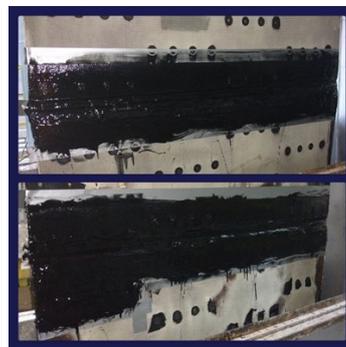
Corn and soybeans falling as the conveyor belt lifts the grains up was causing enough abrasion on the backside of this vertical belt to wear off a complete layer of rubber leaving the layer of the fiber exposed. The wear is worse right next to the joint actually wearing through the fiber layer.

Pressure washed the application area to remove debris and grain dust. Used a handheld wire brush to roughen the fiber surface as the majority of the rubber layer was loose and disbonded and was removed. The outline of the proposed application area was marked and the Belzona 2911 QD Conditioner was applied and allowed to dry per the IFU. Duct tape was applied over the joint seam to allow the application to bridge rather than adhere. The outline was also taped off just inside of where the conditioner was applied. Only one unit of Belzona 2111 D&A Hi-Build Elastomer was mixed at a time, the first batch used to wet out the application area, the second added some volume as well as wetting out the Belzona 9341 Reinforcing Sheet. The last batch smoothed out the application and covered the reinforcing sheet completely.
