# Belzona Seals Wind Turbine Tower Base Against Water Ingress

Customer Location: Wind Farm, West Texas, USA  
Application Date: Summer 2016

Wind Power Tower Base

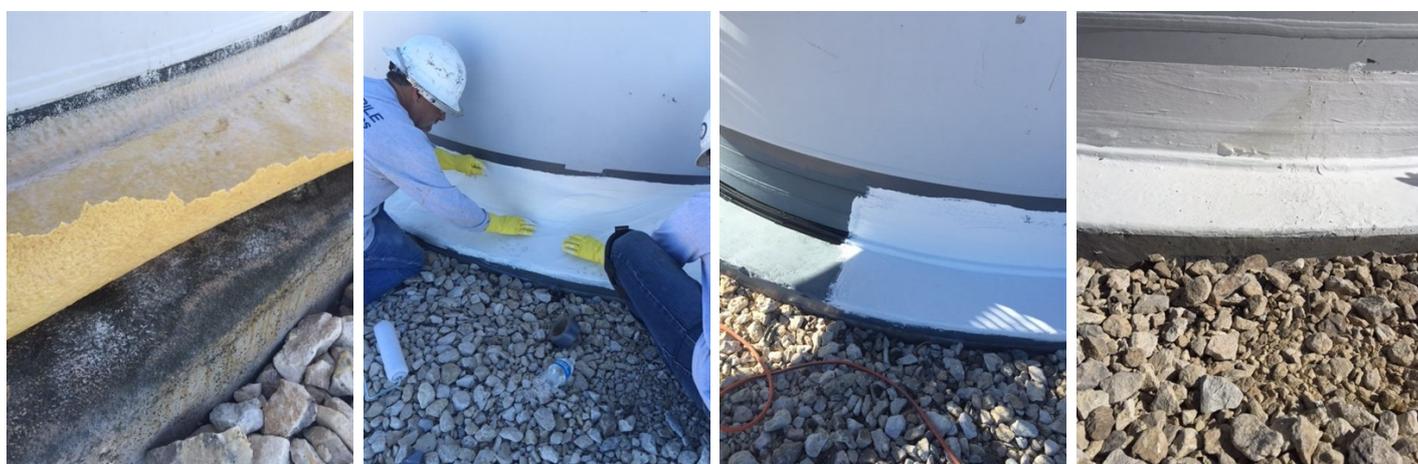
## Photograph Descriptions

Rain water and moisture seeps into the ground and into the wind turbine structure through the base around the tower structure. This over time affects the concrete base and propagates cracks and corrosion at the base of the tower. In this case the current coating failed due to UV degradation leading to delamination from the concrete surface.

- \* 1. The old coating that failed, yellowing and peeling from the concrete surface. ,
- \* 2. The application area being outlined. ,
- \* 3. Application of Belzona 3111 underway. ,
- \* 4. Application completed and tower base sealed with Belzona 3111. ,

The application was carried out in accordance with a modified version of Belzona System Leaflet WPA-1.

Belzona 3111 was a great and easy way to seal the base of the structure and the concrete. The application was simple to do and

gave the Customer that extra flexibility in that area. Short of sealing with some type of concrete filler they had few options for this problem. Sealing the tank base with Belzona 3111 proved to be a cost-effective solution with minimal downtime and interruption to the operation of the turbine.
