# Belzona Seals Oil Leak in Concrete Reservoir In Wind Turbine Tower

ID: 7503

Oil Reservoir Within Wind Turbine Tower

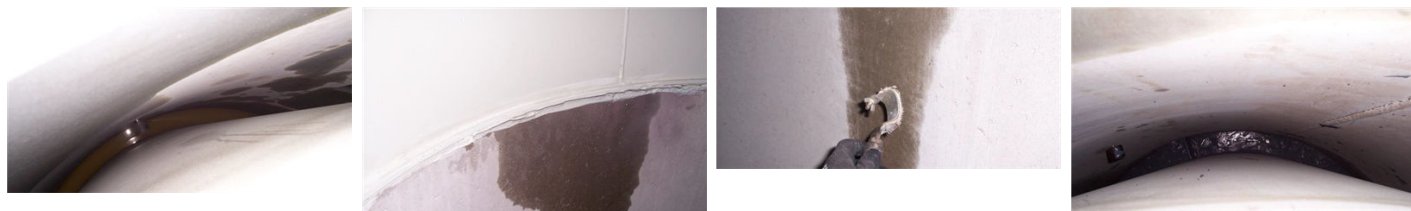
Oil Reservoir located circularly around the wind turbine tower is leaking at the bottom through the concrete and treads into the sealing under it. The oil is being lost and some concrete loss/damage has been sustained over time because of the leaking.

- \* 1. Oil reservoir built around the wind tower. ,
- \* 2. Oil leaking under the reservoir through to the concrete. ,
- \* 3. Surface preparation for the repairing of the damaged concrete with Belzona 4141 and Belzona 4911. ,
- \* 4. Oil reservoir sealed with Belzona 1321. ,

The application was carried out in accordance with a modified version of Belzona System Leaflet TCC-1. The oil was emptied out, the area in the reservoir and under it in the lower floor sealing was thoroughly cleaned. The damaged concrete area was rebuilt with Belzona 4141 using Belzona 4911 for proper adhesion. Belzona 1321 was then poured into the reservoir up to 4 inches from the bottom to seal off any leaks from the concrete or treads to the sealing below.
