Cold Plate Bonding and Traditional Composite Wrap Restores Discharge Pipe

ID: 7504

Customer Location: *Montana, USA*
Application Date: *May 2017*

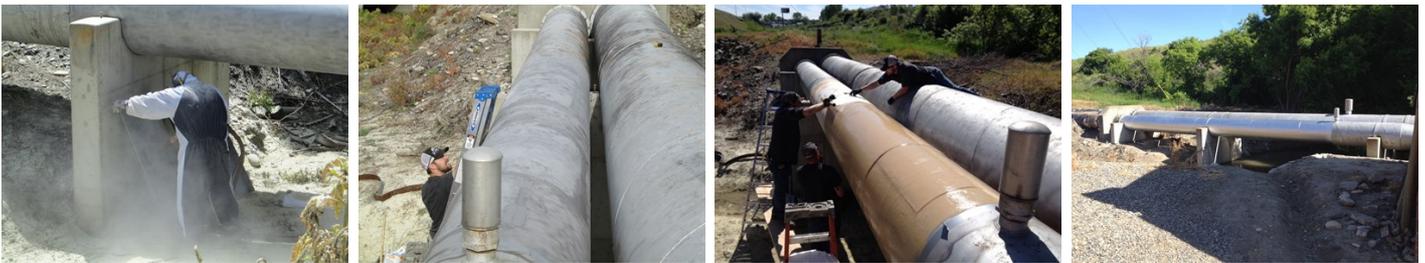
Photograph Descriptions

Years of pumping salty river water eroded this discharge pipe which feeds an irrigation ditch. The severe reduction in wall thickness resulted in numerous failures. The pipe was too thin to weld, and being roughly 30" in diameter, a repair was more conducive to the exposed exterior than on the inside.

- * Surface preparation of saddle plates and pipe ,
- * Some of the numerous plates cold bonded in place ,
- * Second wrap of the composite repair prior to application of an UV protection third coat ,
- * 33 feet of pipe length completed and painted to withstand ultraviolet light exposure ,

A modified Belzona System Leaflet VPF-11 was used. The pipe was already riddled with large through-wall defects, and after abrasive blasting the pipe, numerous small holes developed. These small holes were repaired with Belzona 1111 reinforced with

Belzona 9341. The larger holes were repaired using a plate cold bonding technique. The adhesive used was Belzona 1121 due to its extended working life. A two-wrap traditional composite system, consisting of Belzona 5811 reinforced with Belzona 9331, was applied. A third coat was used to fully encapsulate the reinforcement sheet. A final paint was used to prevent UV degradation.
