# Parks and Recreation Restroom Floor Coated with Belzona

ID: 7505

Industry: *Buildings & Structures*  
Application: *FPA-Floor Problem Areas*  
Substrate: *Concrete*  
Products: *\* Belzona 5811 (Immersion Grade) ,*

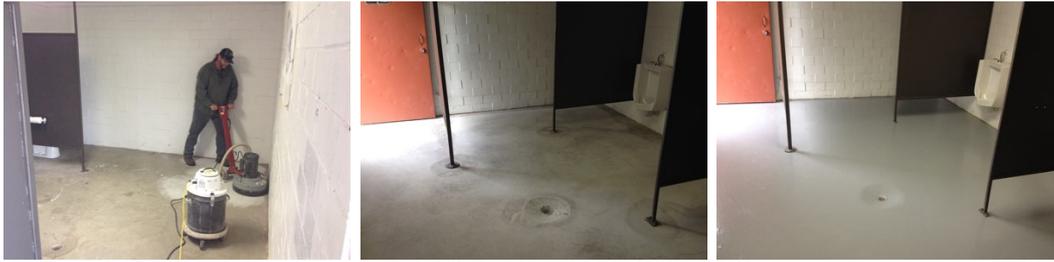
## Photograph Descriptions

- \* Performing floor grinding preparation ,
- \* Surface edge and floor grinding complete ,
- \* Belzona 5811 application complete ,

Rest area needed to be sealed to allow cleaning and disinfecting of public access area. Porous concrete can harbor biological growth.

The application was carried out in accordance with a modified version of Belzona System Leaflet FPA-3. The floor was ground with diamond grinders. Within the overcoat windows two full coats of Belzona 5811 were applied.
