Belzona keeps the water on the outside of the tugboat!

ID: 7507

Industry: Marine
Application: SOS-Ships and Offshore Structures

Steel tugboat hull below the waterline.

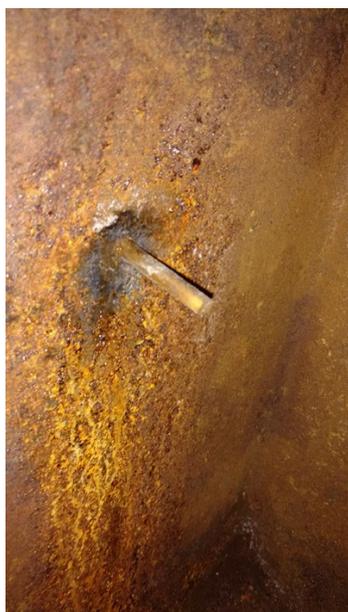
Corroded steel hull developed leaks. The initial response was to insert a wooden dowel into the 1/2" hole. The hole is over 10' below water level on this tugboat. The wooden dowel stopped most of the water but still had some wetness seeping through.

- * 1. Three of the companies tugboats at dock. ,
- * 2. The dowel plugging the hole in the hull. ,
- * 3. Grinding the rust and corrosion off. ,
- * 4. The complete application of Belzona 1212. ,
