Belzona Protects Screw Auger from Abrasion and Chemical Attack

ID: 7508

Screw Auger

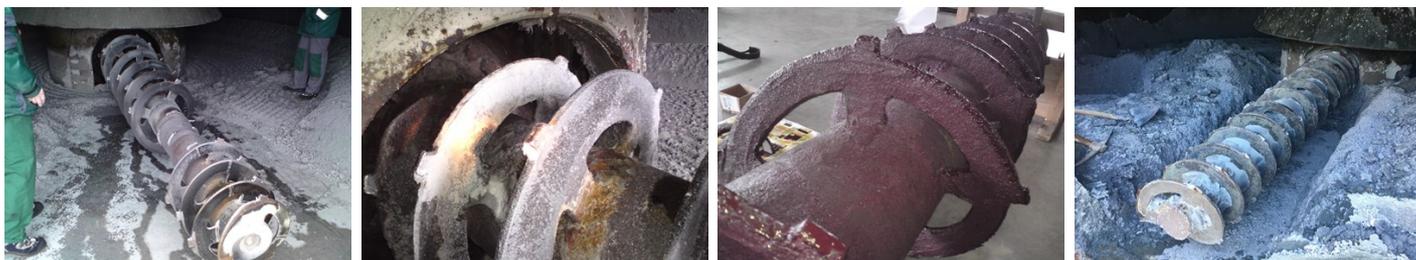
Photograph Descriptions

A coating was needed on to protect a screw auger against abrasion and chemical attack.

- * 1. Before the application ,
- * 2. Before the application (close up) ,
- * 3. After the application ,
- * 4. 8 years later ,

After surface preparation, Belzona 1811 was applied to protect against abrasive attack and Belzona 4311 to protect against chemical attack.
