Cooling system expansion joint protected with Belzona

ID: 7509

Customer Location: Eastern Oklahoma
Application Date: July 2017

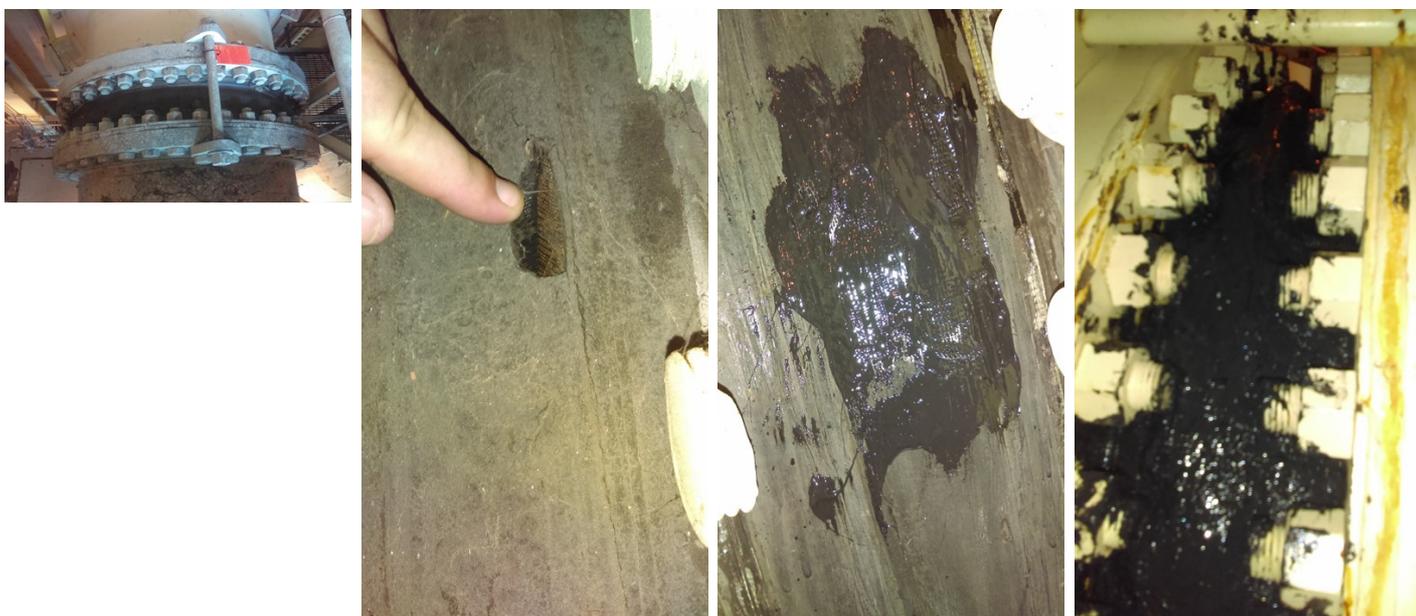
Photograph Descriptions

The rubber joints are deteriorated and have developed slow leaks in a few spots. Replacement joints are very expensive and require an 8 week lead time to order. In the middle of summer, the plant has very limited ability to shut down for maintenance. The plant engineers were concerned that further damage to the joint could result in a blowout, causing massive flooding inside their facility and potentially overheating a turbine.

- * 1: The joint is 52" diameter and 9" wide ,
- * 2: Damaged rubber exposes the steel mesh underneath ,
- * 3: The most severe damaged areas are patched with 2311 and 9341, after prepping and conditioning the surface ,
- * 4: The full surface of the joint is sealed with 2211 and 9341, followed by a coat of 2221 ,

This coal-fired power plant uses river water pumped into several condensers to cool their turbines. There is a rubber expansion joint between the 52" inlet pipe and the condenser head. The cooling water flows through this system at low pressure, high volume.

Application was similar to VPF-05 system leaflet, but slight variations were made due to time constraints.

The customer chose Belzona considering the success of previous repairs in their facility. Their main goal was to seal and protect the expansion joint until their next scheduled outage when the joint can be properly replaced. Belzona's elastomers were a good fit for this purpose. The repair was done on a Friday and the system was ready for operation about 36 hours later, which was a much quicker shutdown than replacing the joint.
