Belzona Fixes International Airport Terminal Fountain

Customer Location: Orlando International Airport, Greater Orlando Aviation Authority (GOAA)

Application: FPA-Floor Problem Areas

Application Date: April 2017

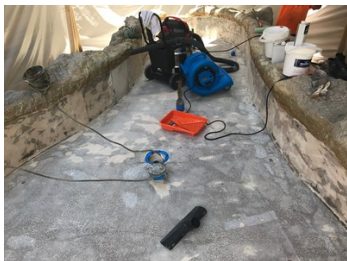
- * 1) Terminal A fountain on first site visit. The other attempts at repairing with foam injection and concrete patches is visible ,
- * 2) A picture of the adjacent side walk that has gotten wet but is shown dry in the picture because the client has shut the fountain down. After the waterfall runs for a couple hours, the sidewalk starts to puddle with water that accumulates ,
- * 3) Application of Belzona 4124 bulkfill under the overlaying rock face ,
- * 4) The waterfall after running at full operation for 3 weeks with ZERO water accumulation on the adjacent side walk ,

Upon initial site inspection, it was discovered that there were a few small holes up under the overlaying rock of the fountain's concrete base. These small holes must have contributed to the waterfall that made its way under the fountain on the other side that puddled on the sidewalk causing a slip, trip and fall hazard. Belzona 4124 bulkfill was used for the cracks and holes and topcoated with Belzona 5233 (clear) and 5122 clear cladding.

Before arrival, the client was asked to remove all vegetation on or near the rock face. Prep was done by grinding under the rock face onto the fountain base. The entire area was pressure washed. Belzona 4124 bulkfill was applied under the rock face creating a concave like design. All the holes under and on top of the rock face and visible cracks were filled. Extra measure was taken to create

barriers to help guide the waterfall into one location for control of flow into the fountain base. Belzona 5233 (clear) was spray applied in a heavy application all over the rock face to help seal the coquina rock. The final application of Belzona 5122 clear cladding was for extra insurance of a water repellent over the entire rock face.

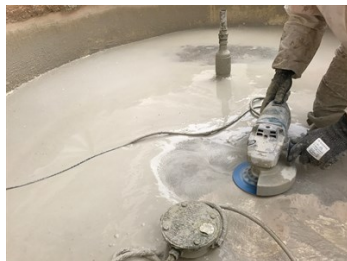
The coquina rock face of Terminal A fountain was having an issue with leaking fountain water from the waterfall attraction back under the coquina rock and continued under the entire fountain foundation that puddled up on the sidewalk edge leading in and out of the terminal to the parking and rental car areas. This area is constantly walked on by thousands of airport customers, tourists and airport employees each day which was causing a slip, trip, and fall hazard issue.
