Belzona Protects New Build Flare Stack

ID: 7514

Industry: Power
Application: TCC-Tanks and Chemical Containment Areas
Substrate: Carbon Steel
Products: * Belzona 1391T,

Customer Location: Korea / Indonesia
Application Date: July 2017

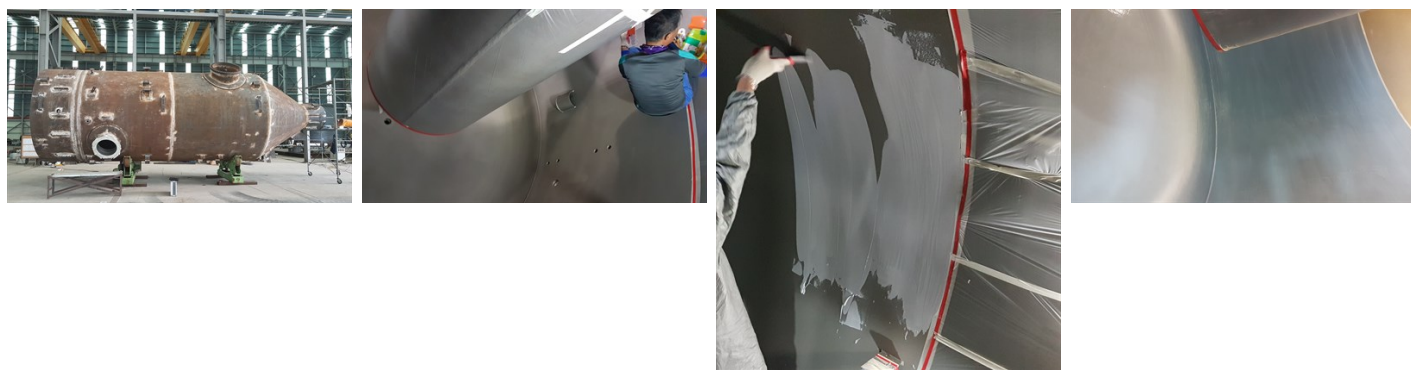
Photograph Descriptions

* 1) Overall View of Flare Stack 2) Blasted Area 3) Applying Belzona 1391T 4) Completed Coating ,

Following surface preparation which met the requirements of the Belzona IFU, Belzona 1391T was applied by hand in accordance with TCC-5.

Belzona 1391T was applied to stop corrosion from occurring the the internal of the flare stack in a prone area. The ceramic fillers in the product help to ensure the wear rate from the erosive forces is kept to a minimum. Belzona 1391T has a long overcoating window which cut down the cost and time of having to blast between the first and second coat.
