# BELZONA 1111 REBUILDS TOWBOAT DRIVE

ID: 7515

Industry: *Marine*  
Application: *SOS-Ships and Offshore Structures*

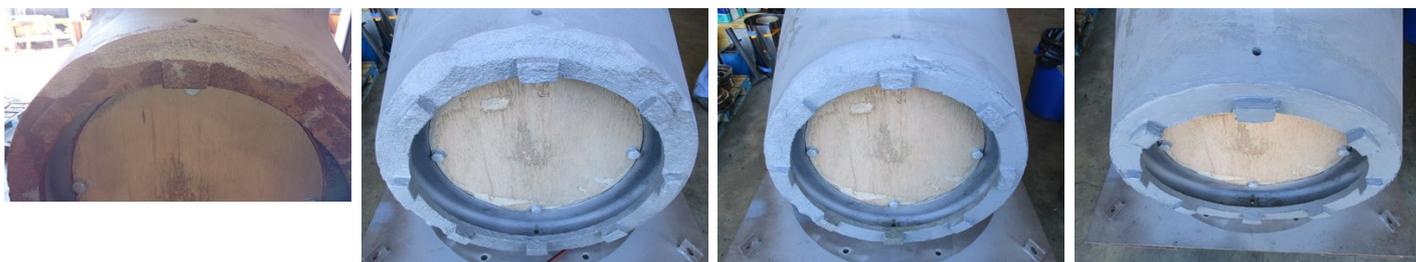
*After 64,000 hours of operation, a fair amount of erosion had occurred starting to compromise the mating face of this drive unit. Up to 1.5 inches of missing steel in the worst places.*

\* Pic 1. Original condition showing erosion. Pic 2. Blasted and ready for the application. Pic 3. Partially completed. Pic 4. Application complete. ,

Erosion damage to the cast steel housing of this Schottel drive on a towboat.

The area of application was grit blasted with alumina oxide for a rough clean finish. MEK was used to wash the area. The first layer of Belzona 1111 Super Metal was applied with a short bristle brush to work it into the rough open pores for optimal adhesion. Slowly, mixing smaller batches the areas were rebuilt. This allowed for the deeper areas to be filled in without worry of slump as the prior layers were setting up as the next layer was applied. After the application was complete, the team waited till the next day to hand finish the application with sandpaper, emery cloth, and flat boards.
