# BELZONA REBUILDS AND PROTECTS KORT NOZZLES

ID: 752

Customer Location: *Tug boat operator - Vancouver, BC  
Canada*

Tug boat kort nozzles

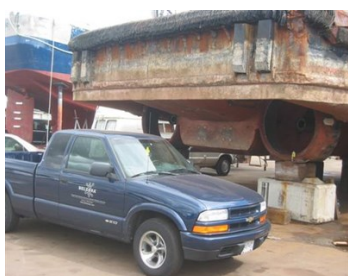
- \* View of tug boat in dry dock. ,
- \* View of one of the blasted nozzles. ,
- \* Application of first coat of Belzona® 1341 with application of Belzona® 1311 to fill the voids and depressions in progress. ,
- \* Second coat of Belzona® 1341 applied to complete the application. ,

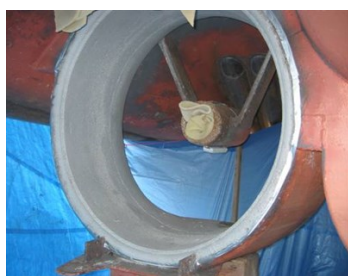
*Kort nozzles badly eroded.*
