Belzona Coats Filter Screens for a Hydro Dam

Customer Location: Red Rock Hydroelectric Dam Iowa
Application Date: 2017

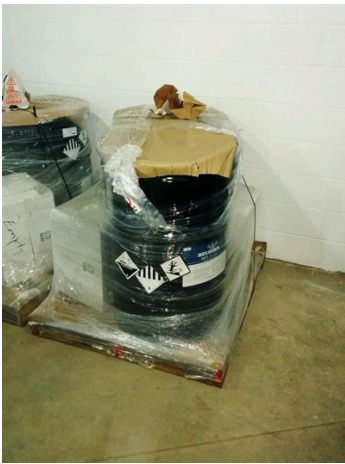
* 1. 5811 ready for use 2. Filter Screen to be coated 3. Screen being coated 4. Finished Filter screens coated with 5811 ,

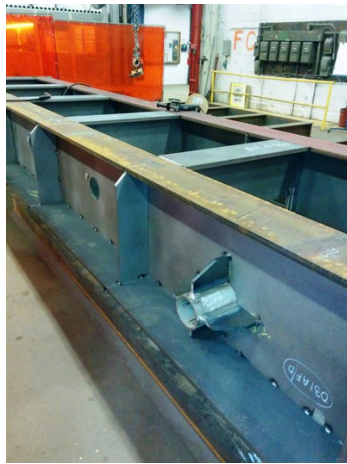
Filter Screens filter debris sizes from the river to acceptable size that can go into the Hydro-power energy production process. Corrosion and impact from sedimentary debris deteriorated the gates over time letting in debris size hazards to the process and equipment.
