# Belzona Coats Filter Screens for a Hydro Dam

Industry: Power  
Application:  
Substrate: Carbon Steel  
Products: \* Belzona 5811 ,

Customer Location: Red Rock Hydroelectric Dam Iowa  
Application Date: 2017

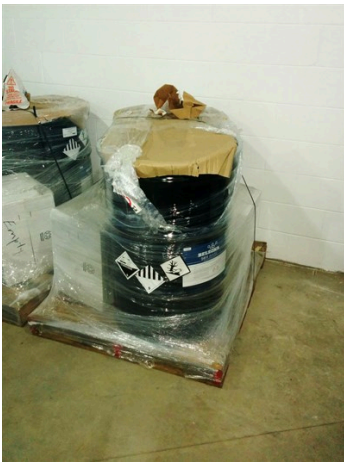
\* 1. 5811 ready for use 2. Filter Screen to be coated 3. Screen being coated 4. Finished Filter screens coated with 5811 ,

Spray Applied airless plural component sprayer and brush applied in edges.

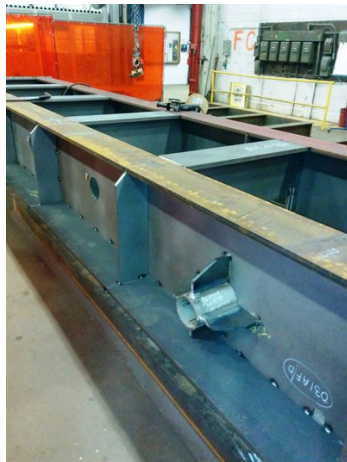
Filter Screens filter debris sizes from the river to acceptable size that can go into the Hydro-power energy production process. Corrosion and impact from sedimentary debris deteriorated the gates over time letting in debris size hazards to the process and equipment.
