# Belzona Repairs 82 Expansion Joints on a Primary Settlement Tank

Industry: Water / Wastewater  
Application: FPA-Floor Problem Areas  
Substrate: Concrete  
Products: \* &bull; Belzona 4111 (Magma-Quartz) ,  
\* &bull; Belzona 2211 (MP Hi-Build Elastomer) ,

Customer Location: Bedford, UK  
Application Date: August 2017

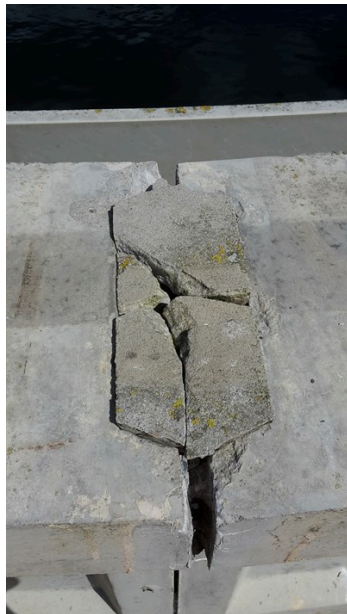
Existing expansion joints had failed. The customer then tried to use a cementitious material to repair them but this also cracked and failed.

- \* 1. The settlement tank. ,
- \* 2. A damaged expansion joint. ,
- \* 3. Nosings rebuilt using a former. ,
- \* 4. Completed expansion joint. ,

The nosings of the joints were rebuilt using Belzona 4111 and Belzona 2211 used as the expansion joint material. The application

was carried out in accordance with Belzona System Leaflets FPA-5 and FPA-7.
