Belzona Repairs 82 Expansion Joints on a Primary Settlement Tank

Customer Location: Bedford, UK

Application: FPA-Floor Problem Areas

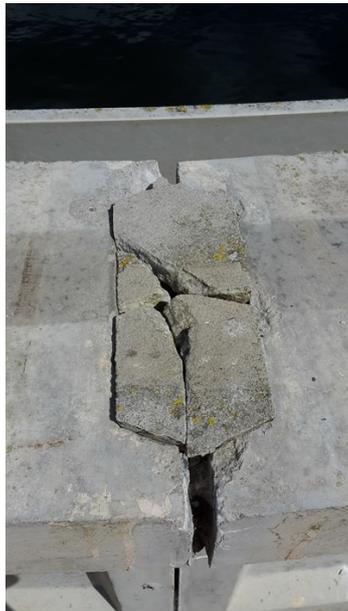
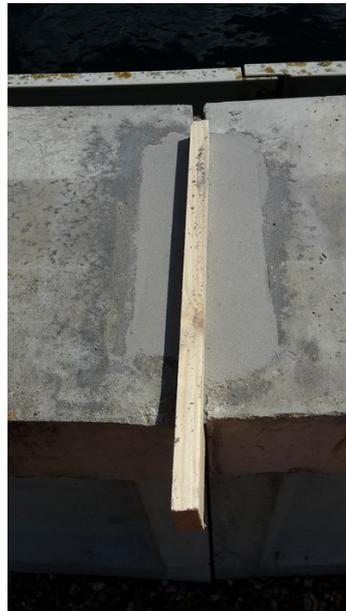
Photograph Descriptions

Existing expansion joints had failed. The customer then tried to use a cementitious material to repair them but this also cracked and failed.

- * 1. The settlement tank. ,
- * 2. A damaged expansion joint. ,
- * 3. Nosings rebuilt using a former. ,
- * 4. Completed expansion joint. ,

The nosings of the joints were rebuilt using Belzona 4111 and Belzona 2211 used as the expansion joint material. The application

was carried out in accordance with Belzona System Leaflets FPA-5 and FPA-7.
