Belzona Repairs 82 Expansion Joints on a Primary Settlement Tank

Customer Location: Bedford, UK

Application Date: August 2017

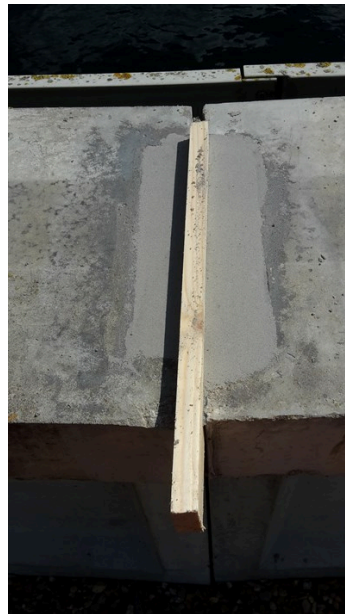
Existing expansion joints had failed. The customer then tried to use a cementitious material to repair them but this also cracked and failed.

- * 1. The settlement tank. ,
- * 2. A damaged expansion joint. ,
- * 3. Nosings rebuilt using a former. ,
- * 4. Completed expansion joint. ,

The nosings of the joints were rebuilt using Belzona 4111 and Belzona 2211 used as the expansion joint material. The application

was carried out in accordance with Belzona System Leaflets FPA-5 and FPA-7.
