# Belzona Repairs and Protects Water Softener

ID: 7533

**Industry:** Chemical & Petrochemical  
**Application:** VPF-Valves, Pipes and Fittings  
**Substrate:** Carbon steel  
**Products:** Belzona 1321 (Ceramic S-Metal),  
 Belzona 1161 (Super UW Metal),

**Customer Location:** Scotland, UK, Pharmaceutical Industry  
**Application Date:** January 2017

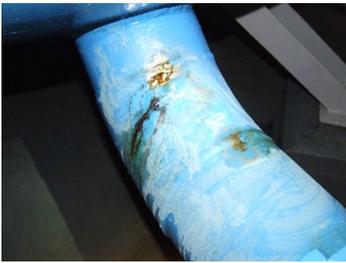
Two welded areas on this pipe had experienced internal corrosion from the internals resulting in pin hole leaks. The water softener contained Brine & ran at approximately 10 degrees C.

Leaking area

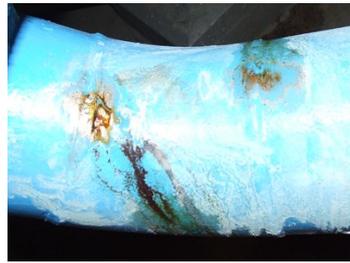
Close up of leak

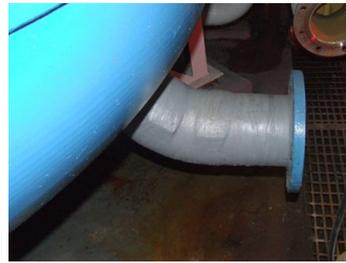
Plate bond &amp; wrap applied

Application was carried out in accordance with a modified version of Belzona System Leaflet VPF-11. Belzona 1321 was applied as a two coat system to the internals. Belzona 1161 and Belzona 9341 reinforcement tape were applied to the external as a composite wrap system.

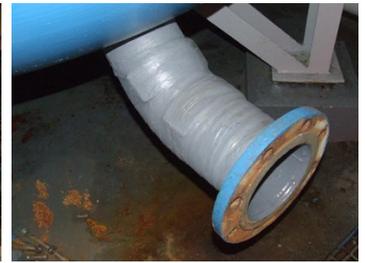
Completed application

Cutting and welding was undesirable due to the environment around the pipe and the safety regulations in place. This traditional method would not have prevented the original issue of corrosion from reoccurring. The Belzona system was installed & cured using external heat to further reduce downtime. This system will prevent the corrosion reoccurring in the future, extending the lifetime of the equipment. The application was inspected in July 2022 & was still in good condition.
