# Belzona Repairs and Protects Water Softener

**Industry:** Chemical & Petrochemical  
**Application:** VPF-Valves, Pipes and Fittings  
**Substrate:** Carbon steel  
**Products:** Belzona 1321 (Ceramic S-Metal),  
 Belzona 1161 (Super UW Metal),

**Customer Location:** Scotland, UK, Pharmaceutical Industry  
**Application Date:** January 2017

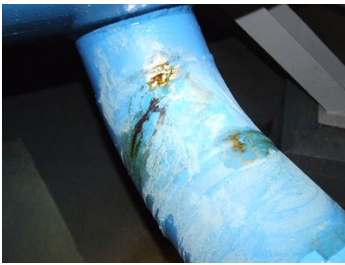
Two welded areas on this pipe had experienced internal corrosion from the internals resulting in pin hole leaks. The water softener contained Brine & ran at approximately 10 degrees C.

Leaking area

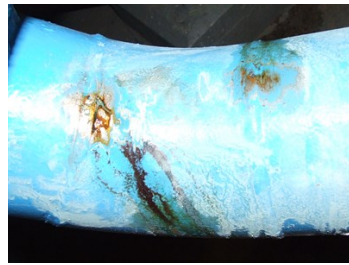
Close up of leak

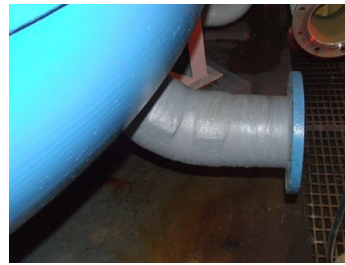
Plate bond &amp; wrap applied

Application was carried out in accordance with a modified version of Belzona System Leaflet VPF-11. Belzona 1321 was applied as a two coat system to the internals. Belzona 1161 and Belzona 9341 reinforcement tape were applied to the external as a composite wrap system.

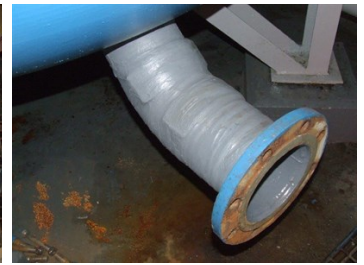
Completed application

Cutting and welding was undesirable due to the environment around the pipe and the safety regulations in place. This traditional method would not have prevented the original issue of corrosion from reoccurring. The Belzona system was installed & cured using external heat to further reduce downtime. This system will prevent the corrosion reoccurring in the future, extending the lifetime of the equipment. The application was inspected in July 2022 & was still in good condition.
