PROTECTING HVAC DUCTWORK WITH BELZONA

ID: 7534

Solution required to seal and protect weathered ductwork insulation.

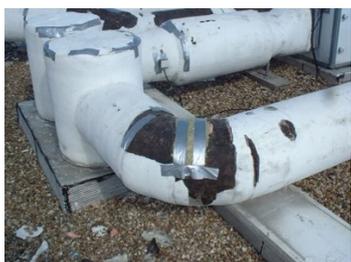
* 1. Damaged insulation 2. Close up of the damage 3. Belzona repair after 14 years in service 4. Belzona repair after 14 years in service ,

Belzona 3211 offers outstanding protection from the elements, including UV exposure. It is micro-porous and will prevent liquid from penetrating through it while allowing any moisture to evaporate, so maintaining thermal efficiency and reducing CUI. This application was photographed in 2017, after 14 years in service. Still in perfect condition.
