BELZONA REPAIRS 4 YEAR OLD PRIMARY SETTLEMENT TANK

ID: 7538

Industry: Water / Wastewater
Application: TCC-Tanks and Chemical Containment Areas
Substrate: Concrete
Products: * Belzona 2211 (MP Hi-Build Elastomer) ,
* Belzona 4111 (Magma Quartz) ,

Customer Location: Waste Water Company, England
Application Date: August 2017

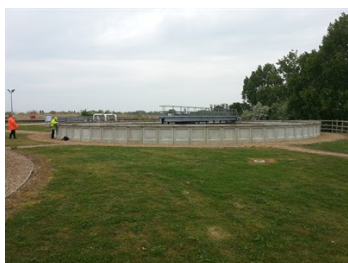
- * 1. The large PST (Primary Settlement Tank) ,
- * 2. Damaged and broken expansion joints before. ,
- * 3. Damaged joint being rebuilt with B4111 creating new expansion gap using wooden formers. ,
- * 4. Completed expansion joints after installing Belzona 2211 ,

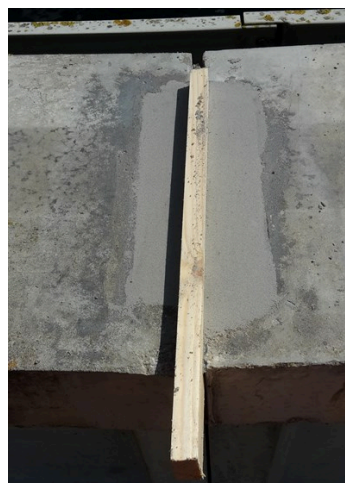
Shortly after the PST tank was constructed 4 years ago, the expansion joints between the 82 x top blocks failed and so were repaired several times by the client using cementitious materials which had again failed. This caused problems for the boom arm to rotate correctly and some of the top horizontal blocks had come loose causing them to rock when the boom arm wheel passed over them

Application was carried out according to Belzona Know-How System Leaflets TCC-11 and TCC-12. All the loose and broken material from the 82 x joints and other areas on the rim were removed. The damaged areas were then rebuilt with Belzona 4111 to create new expansion joint gaps using a wooden former. Belzona 2211 was installed in all the expansion joints both horizontally across the top and up both sides to create a flexible joint. A fillet of Belzona 4111 was installed underneath the horizontal blocks and onto the vertical concrete panels all around the tank to prevent the top rim blocks from rocking
