BELZONA REPAIRS AND PROTECTS MULTIPLE BALCONIES ON LARGE HOUSING SITE

ID: 7540

Application: FPA-Floor Problem Areas

Customer Location: Local Authority (Council), UK

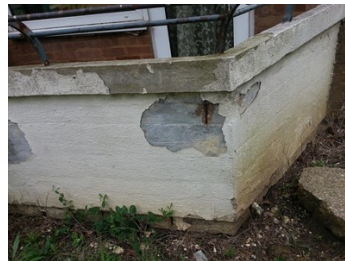
The existing coating on all the concrete balconies was flaking off and in many areas the concrete was broken and cracked where moisture has rusted the steel reinforcing bars inside the concrete structure. The concrete base of the balconies was a slip hazard when wet.

- * 1.The block of Flats ,
- * 2. Damaged Balconies ,
- * 3. Typical problem on a balcony with current coating coming off and damaged concrete exposed ,
- * 4. Balconies after the Belzona repairs and coating has been completed ,

Application was carried out in accordance with a modified version of Belzona System Leaflet FPA-1 and FPA-8. All broken and damaged areas of concrete were repaired with Belzona 4141. The balcony walls and underneath surfaces were coated with Belzona 5151. A non-slip surface was created on the balcony floors with Belzona 5811 blinded out with aggregate.
