# BELZONA 1812 EXTENDS LIFE OF SCREW CONVEYOR

Customer Location: Biomass plant, Scotland

Application: SHM-Solids Handling Machinery

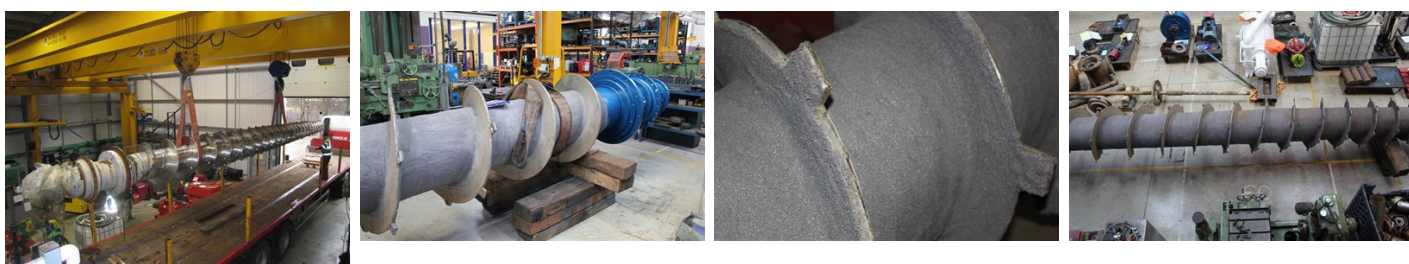
The constant abrasion from wood chippings over the screw surface was found to damage the screw heavily. The shaft and flights would wear out within a few months of operation, and the entire unit would need replacement after just over 1 year.

- \* 1. Delivery of the screw ,
- \* 2. Belzona 1812 applied to the shaft & the 'driving' face of the flights ,
- \* 3. Close up of Belzona 1812 finish ,
- \* 4. Completed application. ,

Application was carried out in accordance with Belzona system leaflet SHM-14. Grit blasting was used to prepare the surface, followed by a lining of Belzona 1812.
