Belzona Saves University Library From Water Ingress

Industry: *Buildings & Structures*
Application: *RPA-Roof Problem Areas*
Substrate: *Glass, Metal*
Products: ** Belzona 3121 (MR7) ,*

Customer Location: *Library at a Manchester University*
Application Date: *2014*

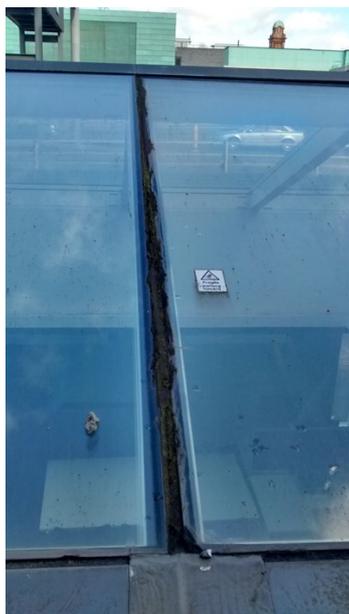
Water ingress was discovered resulting from failure of the sealing materials between the glazed units, caused by UV attack and constant movement due to thermal expansion.

- * 1. Overview of the units ,
- * 2. Close up of the damaged area ,
- * 3. Internal view ,
- * 4. Completed application with Belzona 3121 in place ,

The application was carried out in accordance with Belzona System Leaflet RPA-3.
