BELZONA SOLVES CORROSION ISSUE ON SHEET EDGE ROOFING SECTIONS

Industry: Buildings & Structures
Application: RPA-Roof Problem Areas
Substrate: Steel
Products: * Belzona 3131 (WG Membrane) ,

Customer Location: Leisure Center, Fleetwood, England, UK
Application Date: 2016

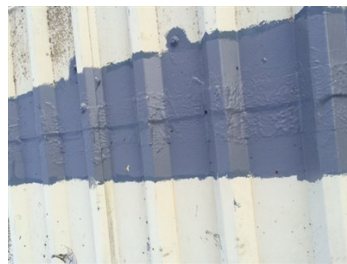
The area is close to the coast making corrosion of metal a real problem on exposed areas of mild steel. This large metal roof was suffering significant sheet edge corrosion damage.

- * 1. Overview of roof area affected by sheet edge corrosion ,
- * 2. Close of of a badly damaged area ,
- * 3. Close up of a repaired area ,
- * 4. Overview of repaired roof area ,
- * ,

The application was carried out in accordance with Belzona Know-How System Leaflet RPA-1.
